Notice for field support to effect of the earthquake in Eastern Japan on products

As of September 15th,2011
OP Support Dept., KMBT CS Headquarters

Due to effects from the earthquake taken place at Japan on March 11, part of electronic components (microprocessors) are in current use cannot be procured and our production will be performed using microprocessors with different model codes. This measure produces an effect on FW compatibility that requires attention during field support activities.

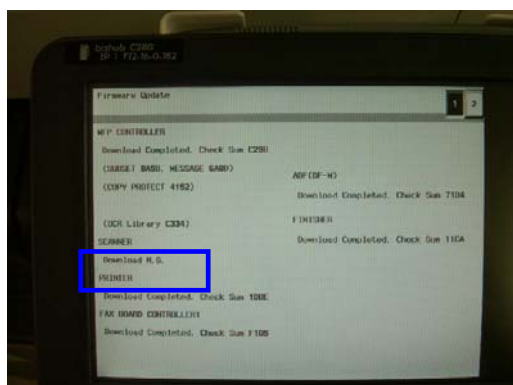
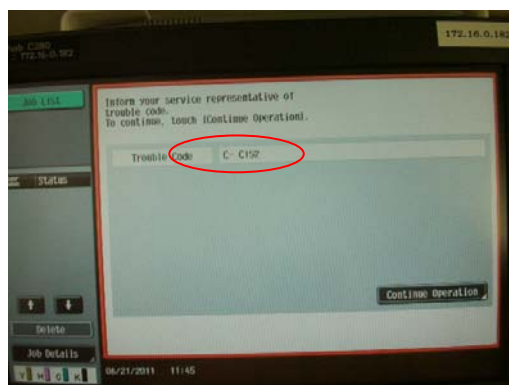
The installation of the firmware will complete without error except Scanner module. On the update screen, “Download N.G.” will be indicated for the Scanner update

This is because the current MFP FW does not contain the scanner FW that is compatible with substitute microprocessor.

The “C-C152” error occurs thereafter when the main power switch is turned OFF and ON, causing the panel to hang up. The “C-C152” error cannot be reset using the service mode. The error persists until the correct FW is written.

- When downloading the current MFP FW to the MFP board mounted with substitute microprocessor, select “NO” for the Scanner FW.

- If the installation is mistakenly performed with the resultant “C-C152” error occurring, rewrite the program for only the scanner FW module using the new MFP FW described in “6) FW release from KMBT”. Install the FW again by following the procedure given below.

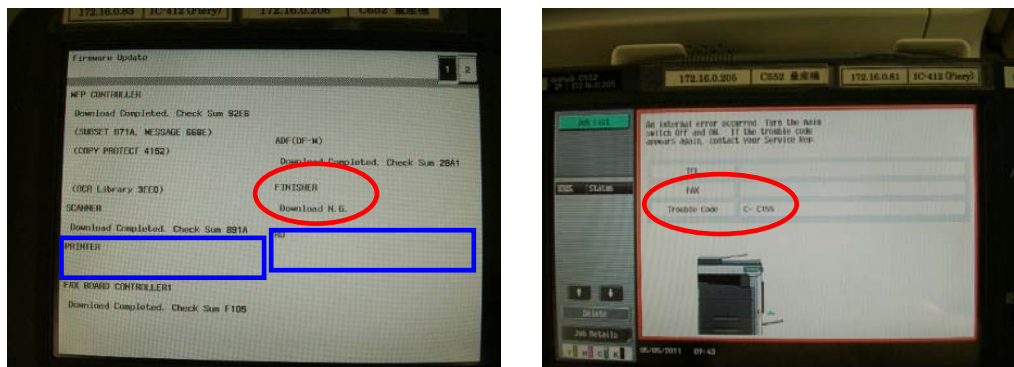
C-C155 appears after main power is turned OFF and ON

If the condition of the combination marked with x in the table shown in “FW compatibility” occurs, writing of the finisher (for FS-526) FW fails (Finisher FW is not written). When the main power switch is then turned OFF and ON, the malfunction code “C-C155” appears.

When you try to install the current MFP FW of the firmware in the MFP with FS-526 connected, it may happen if substitute microprocessor (H8S/2427 or H8S/2426) is mounted on the controller board of FS-526.

Performing updating with “Yes” selected for all modules will result in the updating of Finisher FW failing, which stops the updating procedure. As a result, FW of the printer and RU to be subsequently updated will not be installed. If the main power switch is turned OFF and ON under this condition, the malfunction code “C-C155” appears because of the Finisher FW not written.

- To rewrite the older Card Ver. with the current MFP FW for the MFP that uses the FS-526 mounted with a substitute microprocessor (H8S/2427 or H8S/2426), be sure to select “NO” for the Finisher FW.

If the installation is performed mistakenly and a “C-C155” occurs, install the FW again by using the finisher-only FW to be released separately and following the procedure given below.

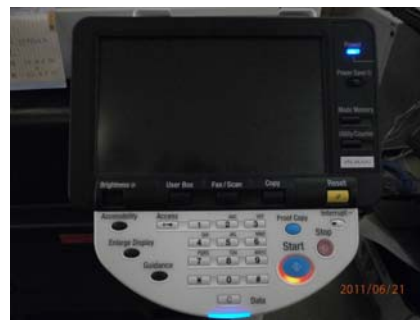
When Rev2.1 CPU is booted with current Boot ROM, the following symptom will be appeared. Hang-up will invariably occur during a procedure to exit from the sleep mode (*1) or when the sub-power switch is turned OFF and ON.

- The LCD backlight is OFF.
- The start button is lit up red.
- The panel is inactive.

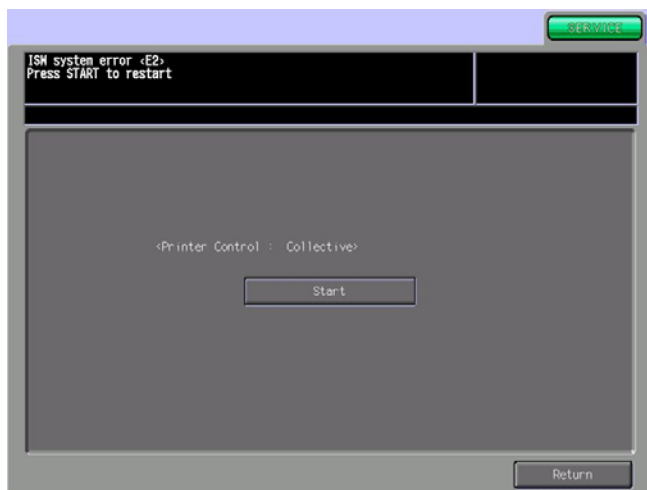
In case of wrong firmware is loaded, system error “E2” is indicated as a writing error. When the error code is indicated, the entire program inner flash memory is erased already, and the print engine will not work unless right firmware is reloaded.

You need to reload right firmware, but C-C104 is indicated just turn OFF/ON the power switch. Turn OFF the sub-switch, and turn ON the sub-switch with keep press the “UTILITY” key in order to go into the service mode, which is usual way to load firmware after installing new printer control board.

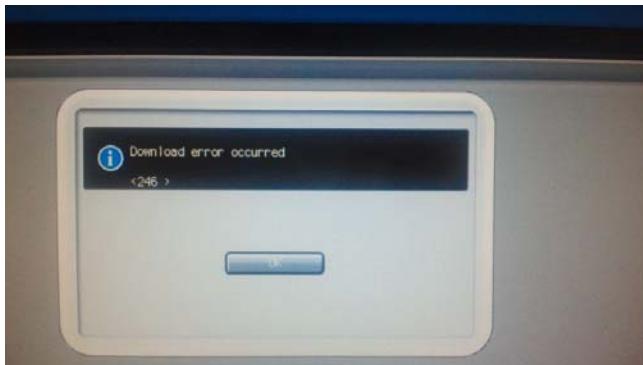
Either error code **246** or **247** is indicated on the display. When sub-switch is turned OFF/ON, print engine is recovered with the previous firmware version. Reload the correct firmware version by usual firmware loading.

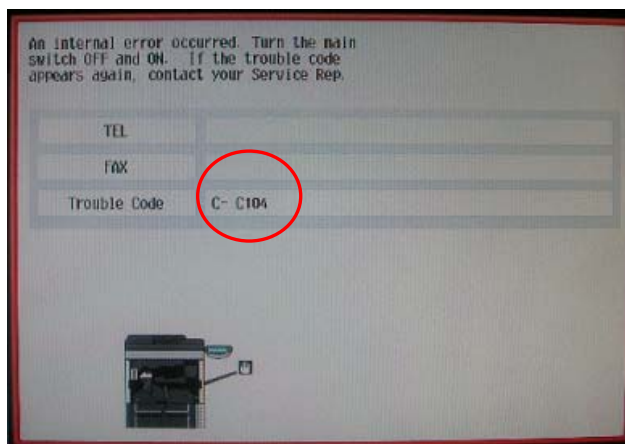
In case of wrong firmware is loaded, ISW itself is completed at that time. However, C-C104 is indicated on the display after initialization of the print engine. The error code cannot be recovered unless right firmware is reloaded.

- 1) Turn OFF the sub-switch, but main switch must be keep ON.
- 2) Keep press UTILITY, and turn ON the main switch in order to go into the service mode.
- 3) Press “trouble reset”, and then press “OK”.
- 4) Go into the service mode, and reload right firmware.
- 5) Turn OFF/ON the main switch, and verify the firmware version just reloaded.
