Notice for field support to effect of the earthquake in Eastern Japan on products

As of September 15th,2011
OP Support Dept., KMBT CS Headquarters

Due to effects from the earthquake taken place at Japan on March 11, part of electronic components (microprocessors) are in current use cannot be procured and our production will be performed using microprocessors with different model codes. This measure produces an effect on FW compatibility that requires attention during field support activities.

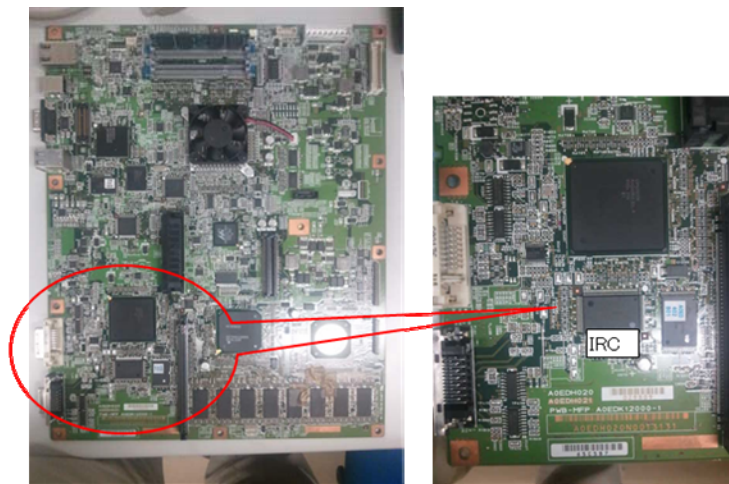
Applicable board: MFP board (PWB-MFP)

Board number
Amur1/2	A0EDH020
Amur3	A0EDH021
Taiga0/1	A1UDH021 [A0UDH023 (GSA)]
Taiga2/3	A1UDH020 [A0UDH022 (GSA)]

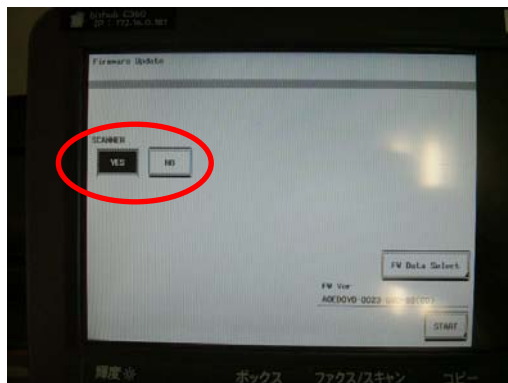
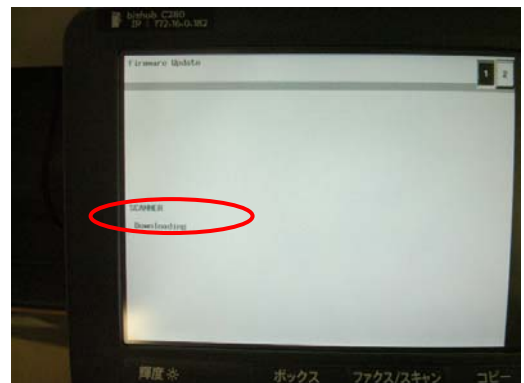
How to rewrite the scanner FW with Scanner-only FW.

The “C-C152” error occurs thereafter when the main power switch is turned OFF and ON, causing the panel to hang up. The “C-C152” error cannot be reset using the service mode. The error persists until the correct FW is written.

- If the installation is mistakenly performed with the resultant “C-C152” error occurring, rewrite the program for only the scanner FW module using the new MFP FW described in “6) FW release from KMBT”. Install the FW again by following the procedure given below.

Procedure: Use the new MFP FW to rewrite only the scanner FW.

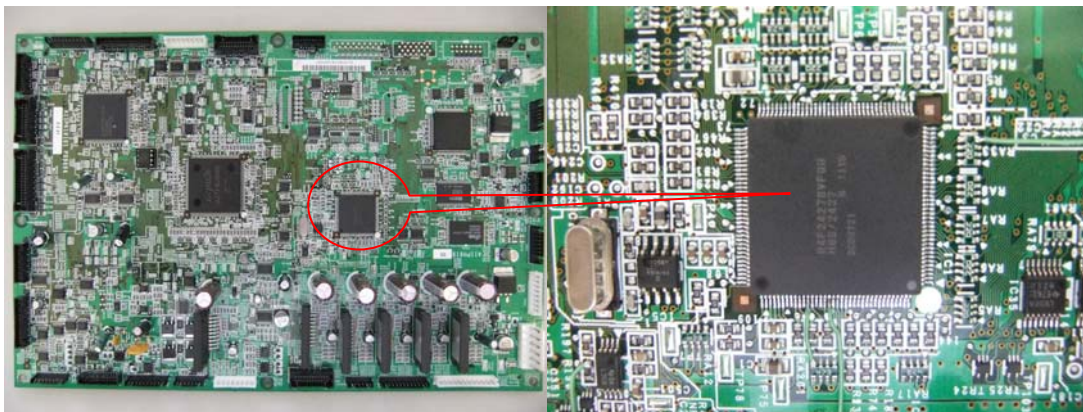
Components to be changed: HD64F2378BVFQ35V [H8S/2378] → To R4F24278 [H8S/2427] or R4F24269 [H8S/2426]

Applicable board: A11PH010E (FS-526 FNS control board)

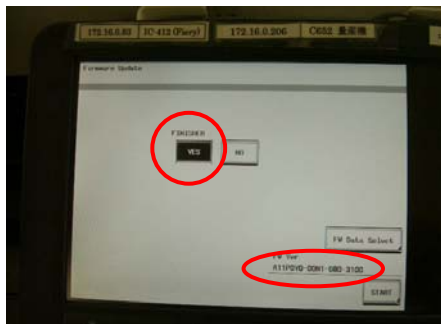
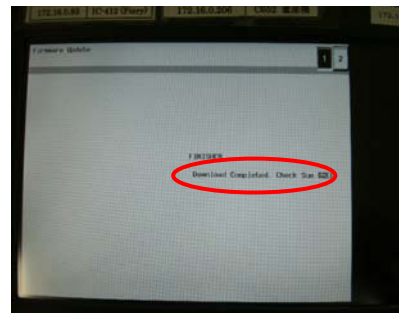
If the condition of the combination marked with x in the table shown in “FW compatibility” occurs, writing of the finisher (for FS-526) FW fails (Finisher FW is not written). When the main power switch is then turned OFF and ON, the malfunction code “C-C155” appears.

If the installation is performed mistakenly and a “C-C155” occurs, install the FW again by using the finisher-only FW to be released separately and following the procedure given below.

Step 1) Rewrite the Finisher FW only by using FS-526 Finisher Program for All microprocessor.

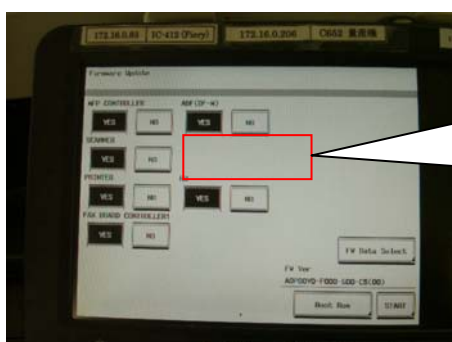
When an attempt is made to download the above MFP FW on the MFP connected with the FS-526, the finisher FW portion is blank to show no selection screen. (The conventional selection screen appears on an MFP connected with a finisher other than FS-526.)

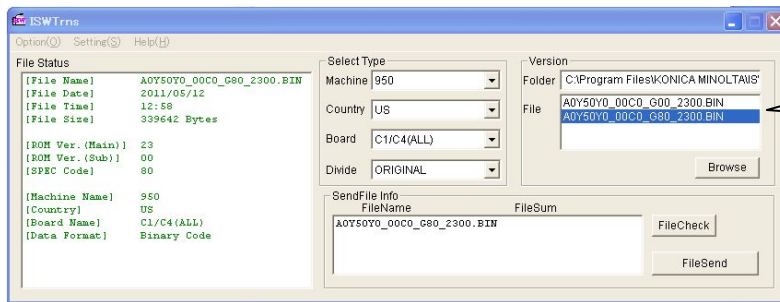
* Internet ISW is not recommended it is because of once wrong firmware is loaded, the print engine does not work unless correct firmware is reloaded.

You can load substitute firmware onto the control board with substitute microcomputer by usual ISWTms. Nevertheless, services engineers need to choose the right firmware in correspond to the control board.

Choose right firmware here.
A0Y50Y0_00C0_**G80**_2300.BIN

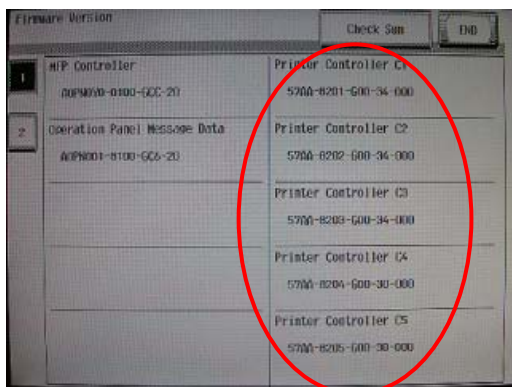
Printer control program (C-ROM)

The following is firmware modules, which can be incompatible depending on combination with control board type.

Control board in corresponding to firmware:

The difference between original firmware version and substitute firmware version is the last digits either 00 or 80.
